Causes of premature ravelling with single-layer Porous Asphalt

ABSTRACT: In the Netherlands the average service life of single-layer Porous Asphalt (PA) 0/16 with standard 70/100 pen grade bitumen is 11 years for the slow lane and 16 years for the fast lane. The end of the service life is mainly caused by the loss of coarse material from the surface (ravelling). However, sometimes the service life is much shorter. This paper discusses an investigation into the causes of premature ravelling problems of a PA road section, which occurred within three years after laying.

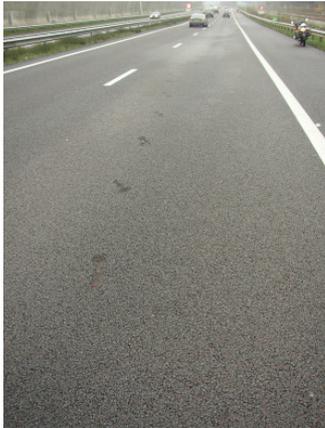
Already after 1 year service life the first damage was observed. Damage showed up in small potholes and initial ravelling randomly over the width of the road surface. This is very unusual, because experience has learned that the first ravelling starts to show up in the slow lane after 5 and 8 years of service.

Figure 1: Example of potholes in A76

The contractor repaired all the damaged locations at his own cost. Cost included traffic measures, cleaning and drying of the holes, filling of the holes with special mortar and adhesive and placing fine split on the PMB (polymer modified binder of the mortar) to satisfy skid resistance requirements. Figure 1 shows an example of a location with holes and figure 2 gives an impression of the cleaning and drying of the holes. The surface surrounding the repaired holes was treated with a special developed emulsion to prevent accelerated stone loss. The contractor could not explain the premature damage of the PA. The road agency decided in good consultation with the contractor to try and find the cause of the premature damage. A research plan was made to try and find the cause.

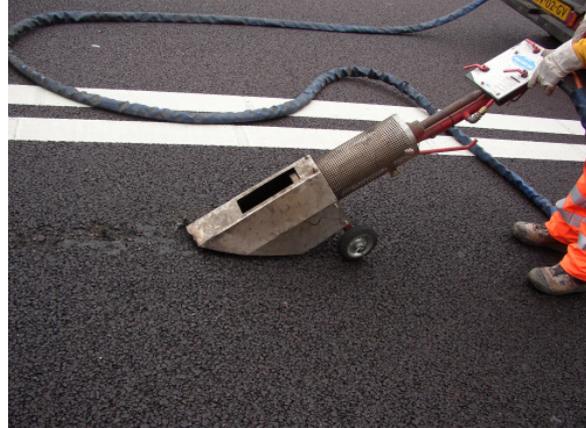
Figure 2: Cleaning and drying of potholes in A76

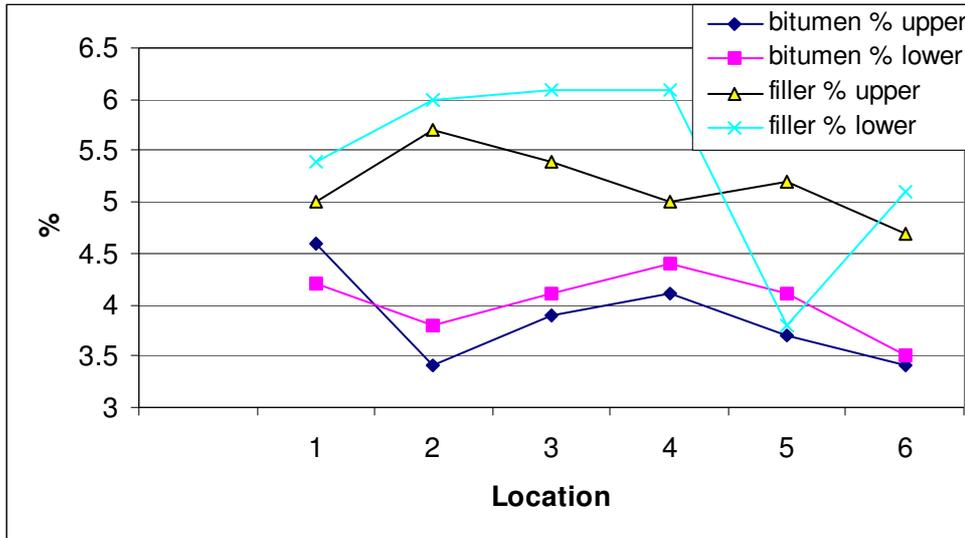
Figure 5: Example of variation in bitumen content and filler smaller than 63 µm over the lane width (location cores) at km 12.18950 for the top parts of the cores.

The mix design of 29 August 2002 allows for an average minimum bitumen content of 3.95 %. The average bitumen content of the top parts is 3.86%, so this is too low. The average bitumen content of the the bottom parts is 4.14%, which is low but within the tolerances.

For the mix design of 5 June 2003 an average minimum bitumen content of 4.15 % is allowable. The average bitumen content of the top parts is only 3.86 %, which is very low. The average bitumen content of the bottom parts is only 4.18 %, which is also very low but just within the tolerances.

It can be concluded that the lower bitumen content in combination with the higher filler content will result in a dry mortar, which will have a negative effect on the resistance to ravelling.

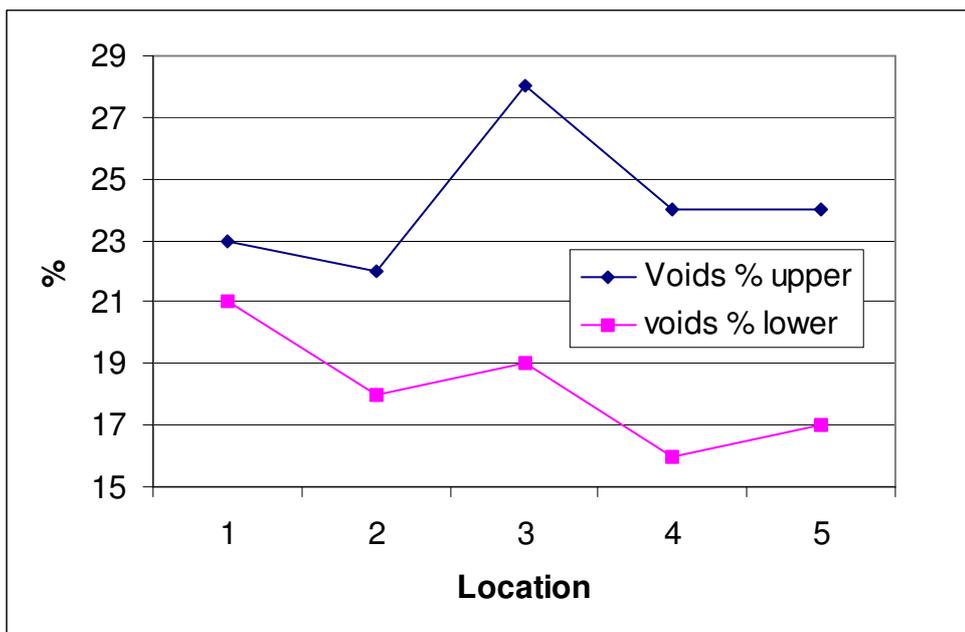
Figure 6: Example of variation in air-voids content of top and bottom parts over the lane width (location cores) at km 12.14125

Because the parts with very high air-voids are not linked to a very low bitumen content, it can be concluded that the degree of the composition of 20 of the 44 was in such a way that only a low service life can be expected.

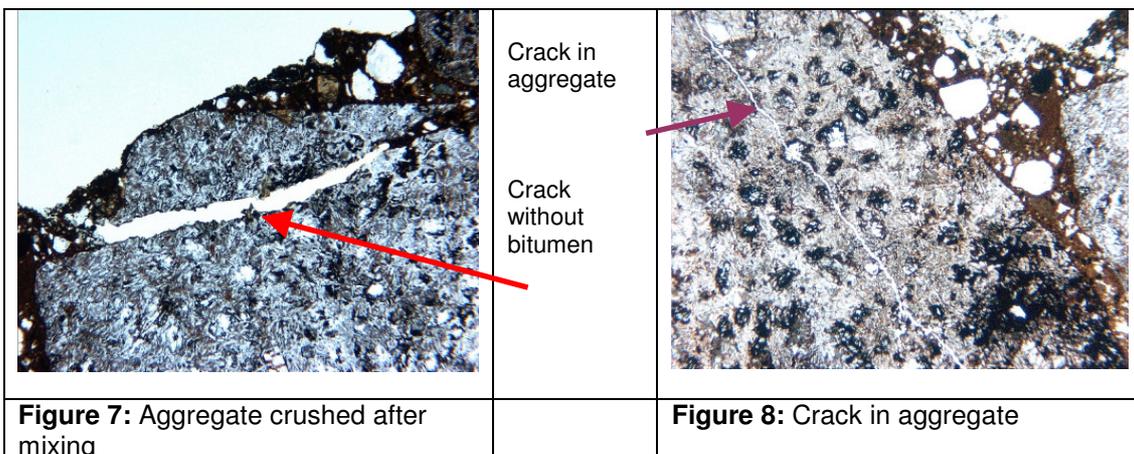
In [12] results of a limited research on thin sections carried out by Danish Road Institute (DRI) were reported. The thin sections were prepared of two cores taken from the A76. From figure 7 and 8 it can be seen that the cracks that are present in the aggregate probably developed after mixing because they are not filled with bitumen.

The cracks probably developed during the compaction process or due to traffic loading. These cracks are remarkable because the resistance to crushing determined with the Los

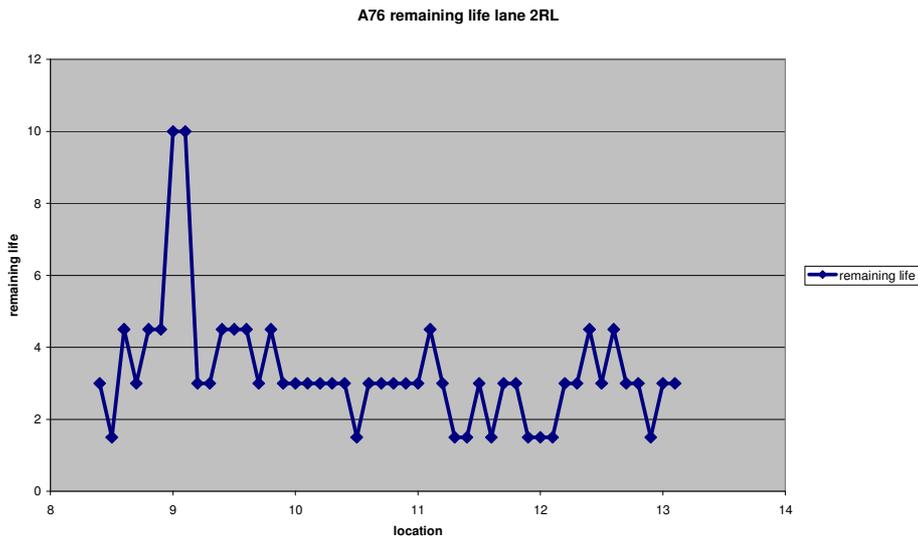
Figure 10: Example of remaining service life of lane 2RL of the A76

With the assumption that the service life as observed in Limburg [1] is according a normal distribution, this means that there is a chance of 14 % that the service life is less than $10.7 - 3 * 1.7 = 5.6$ year. With the age of the PA on the A76 in mind and the found service lives it can be concluded that the PA on the A76 will not achieve a service life of 5.6 year and will perform very poor.
